First Five-Year CERCLA Review of Seven Pearl Harbor Naval Complex National Priorities List Sites

JOINT BASE PEARL HARBOR-HICKAM, OAHU, HAWAII

September 2014

**Department of the Navy
Naval Facilities Engineering Command, Hawaii
400 Marshall Road
JBPHH HI 96860-3139**

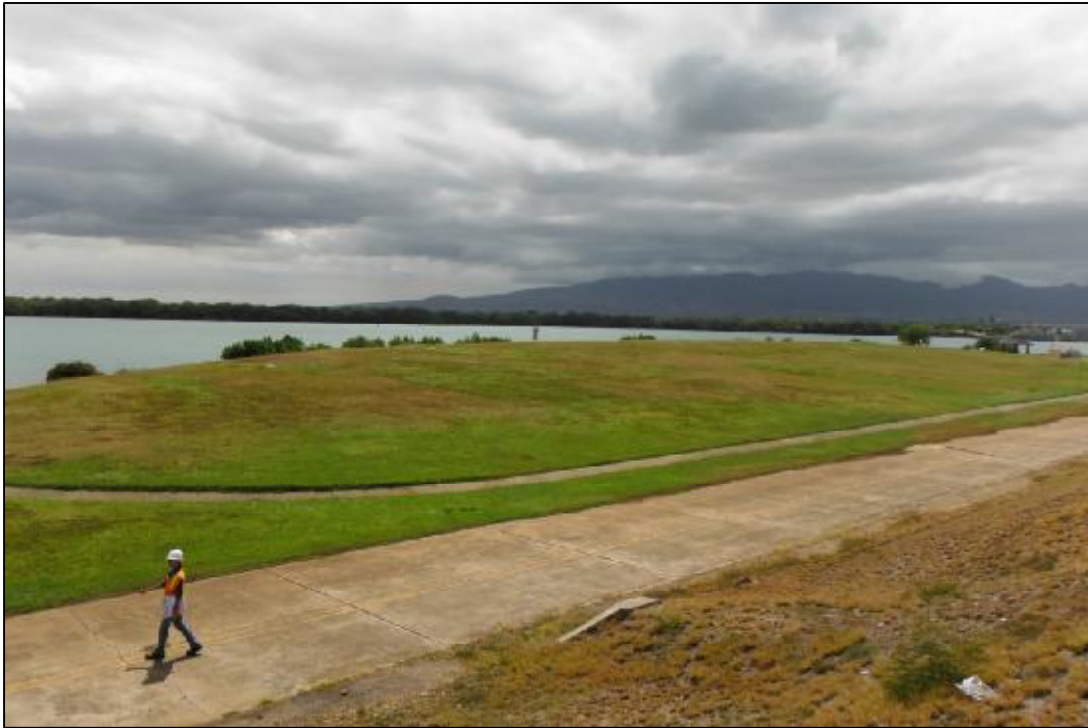
Photograph No. 1: Overview of Ford Island Landfill site, looking northwest.

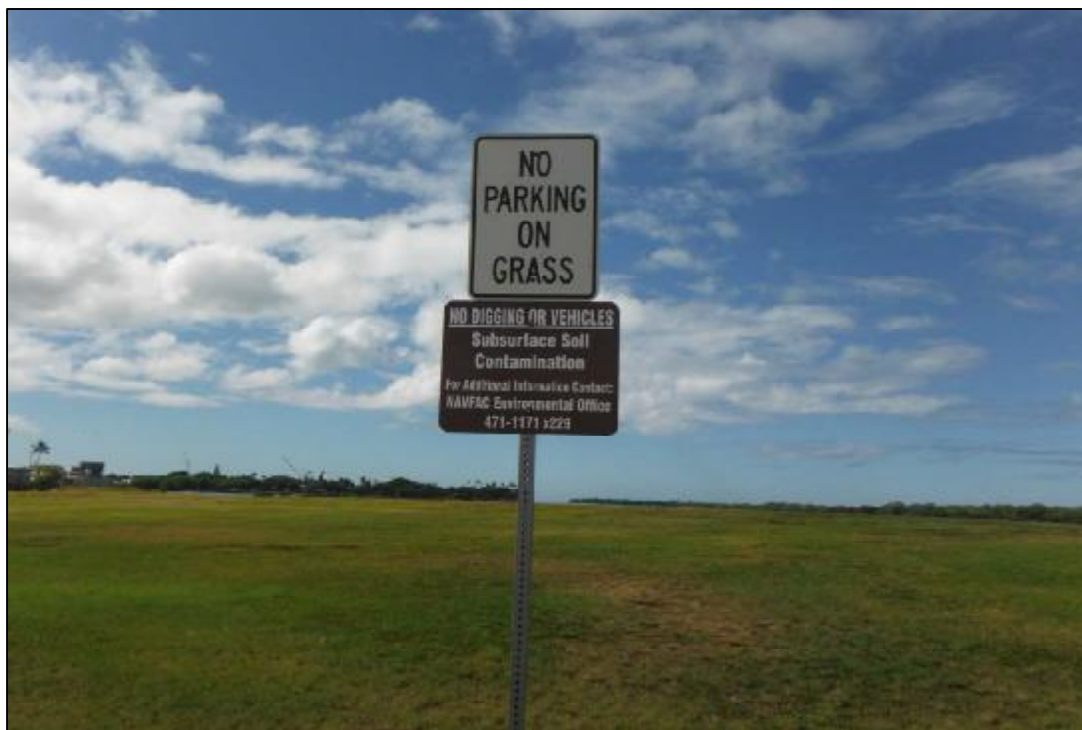
Photograph No. 7: Signage prohibiting digging and vehicles on the landfill surface.

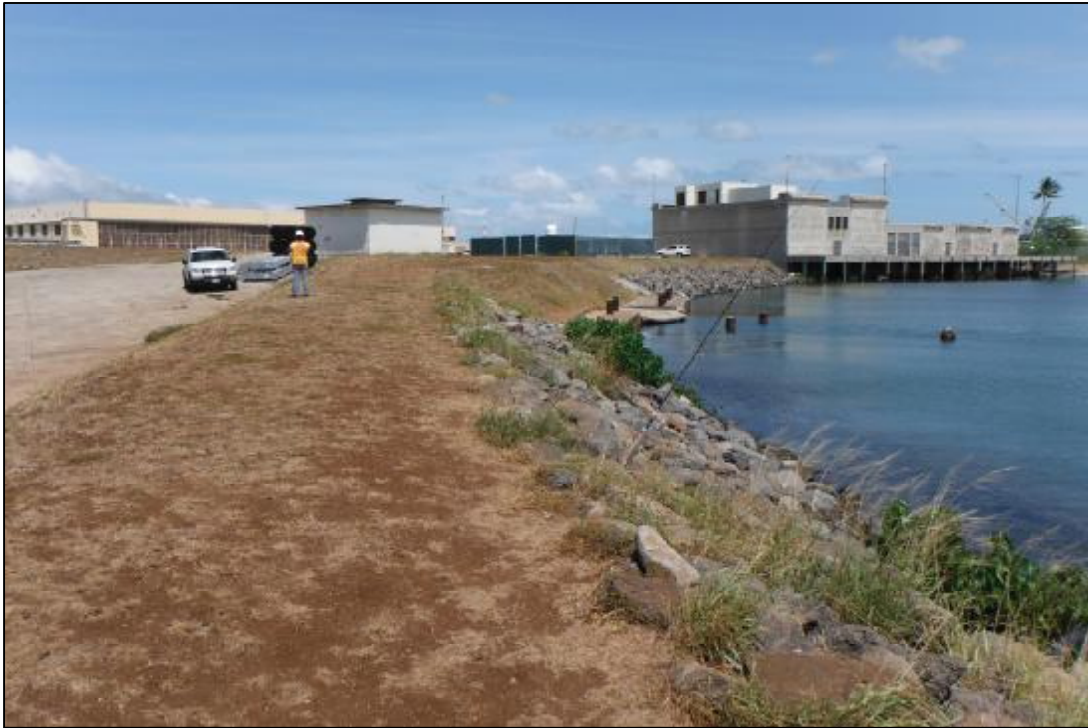
Photograph No. 1: Overview of Bldg. 284 site, looking southeast. Dry grass and bare soil in foreground.

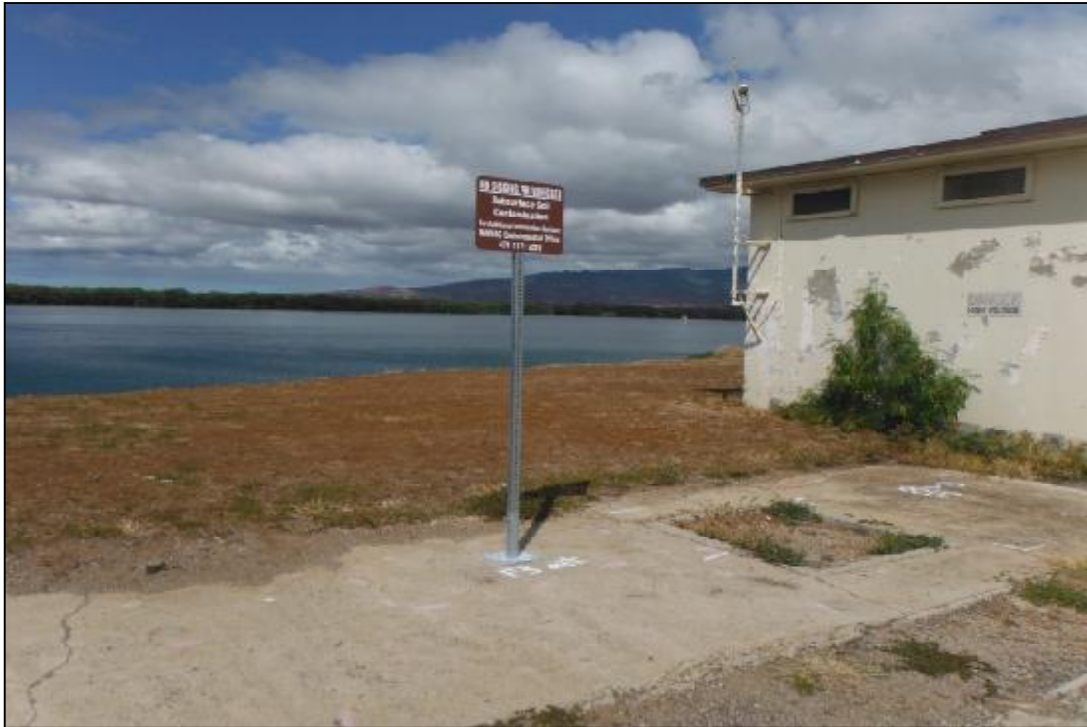
Photograph No. 5: One of three LUC signs installed at the Bldg. 284 site.

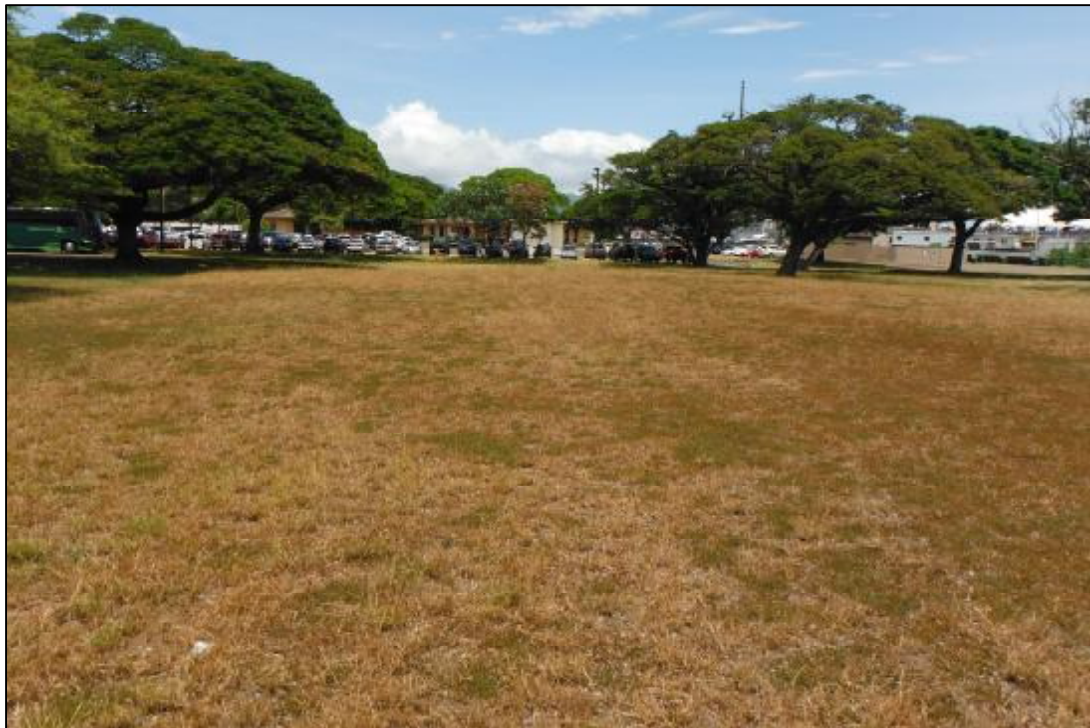
Photograph No. 6: Overview of soil cap and dry grass at former Bldgs. 80/302, looking east.

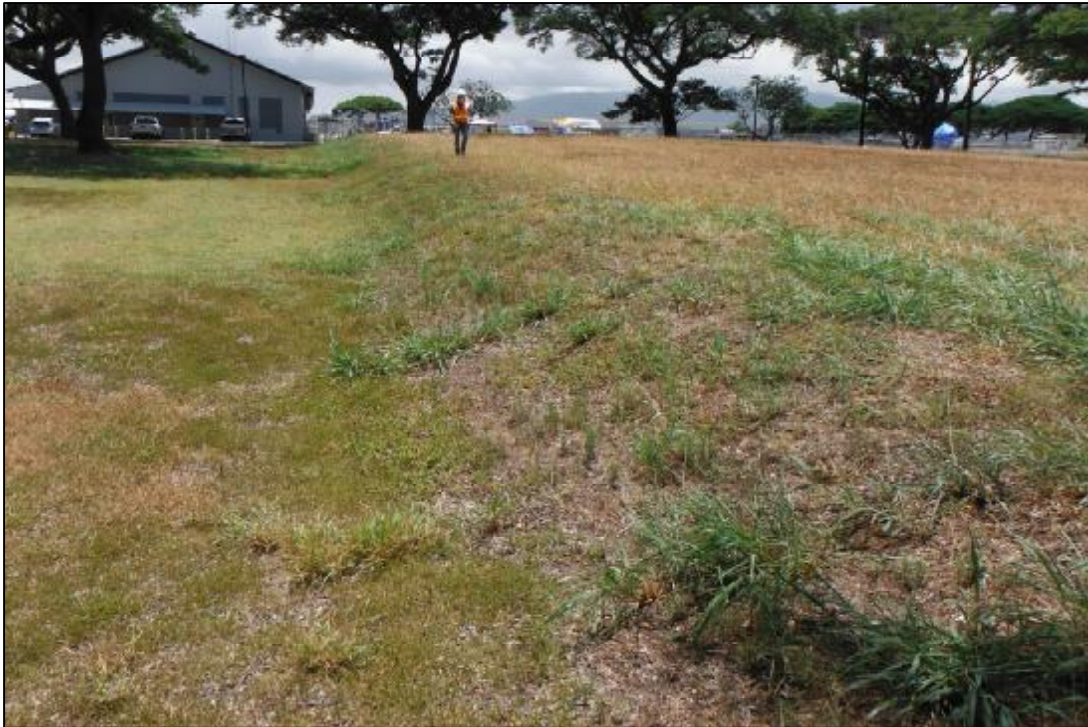
Photograph No. 7: Side-slope of soil cap at former Bldgs. 80/302, looking west.

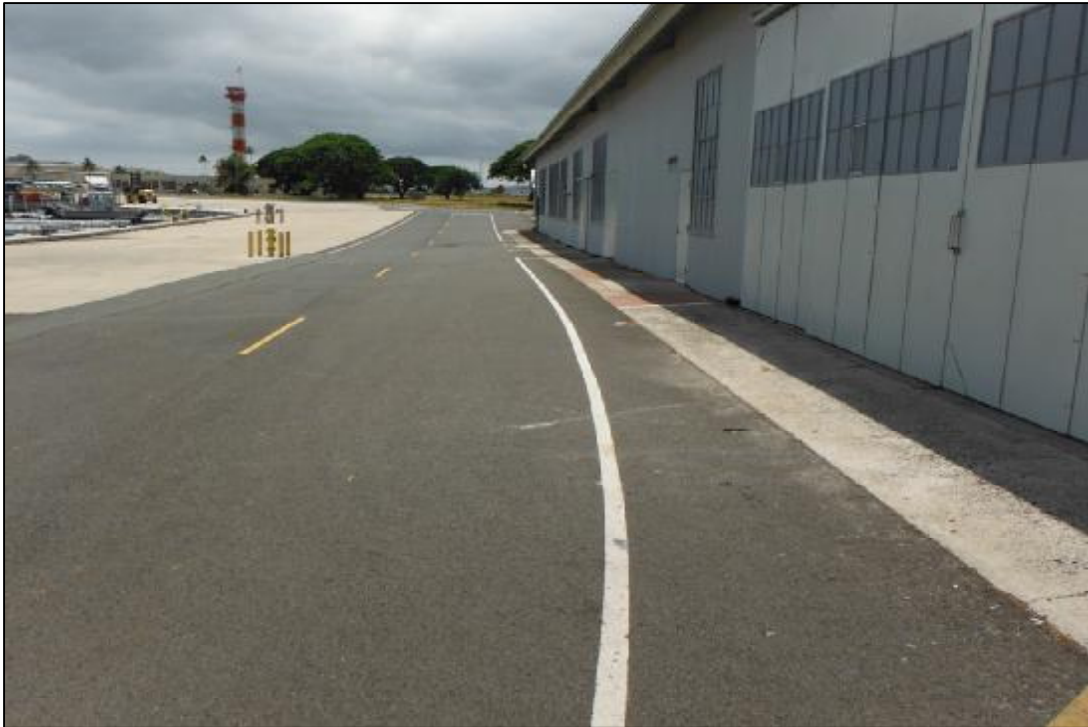
Photograph No. 11: Overview of paved LUC area south of Bldg. 3, looking west.

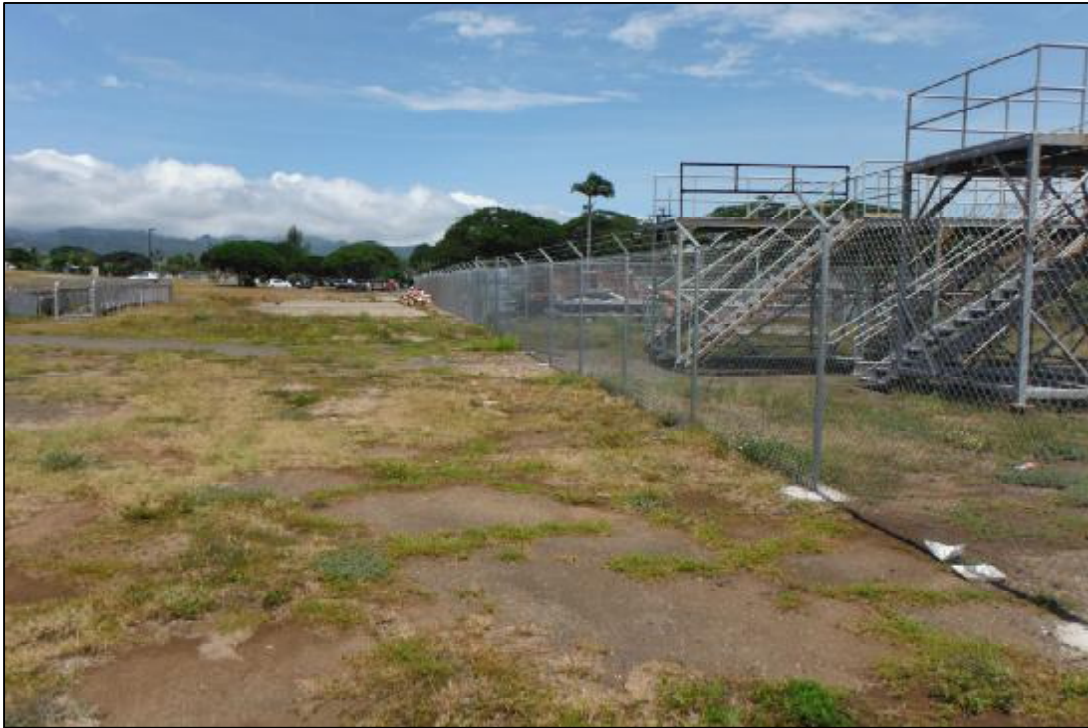
Photograph No. 15: Fencing surrounding the LUC area, looking east.

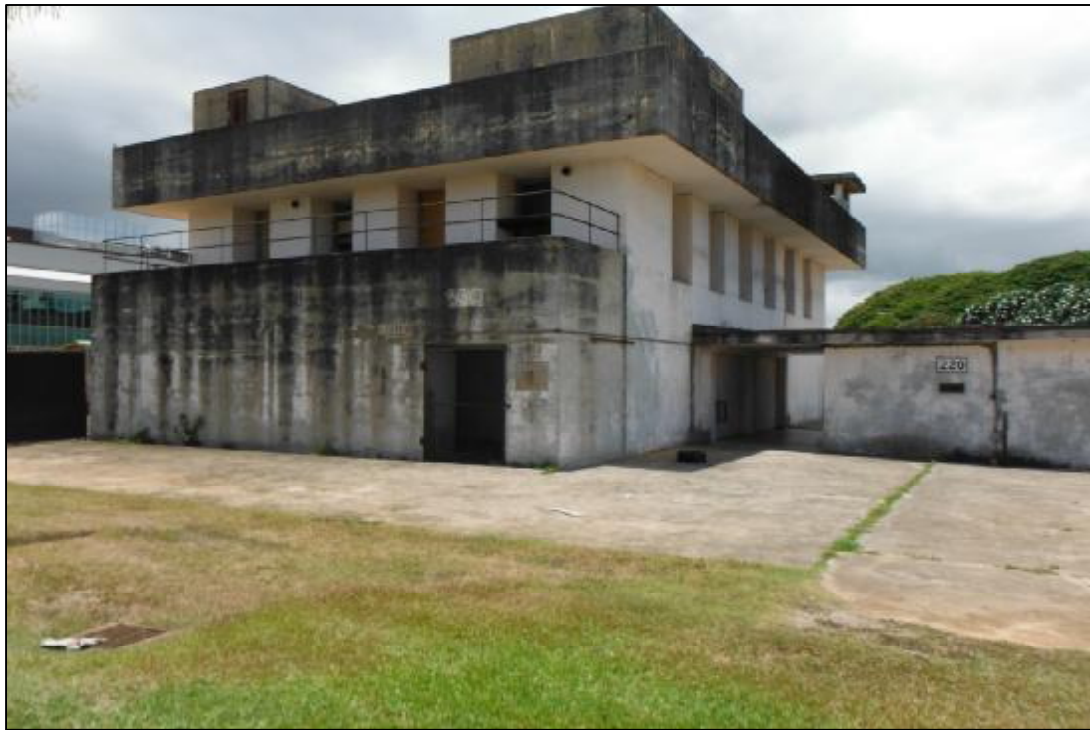
Photograph No. 1: Overview of the exterior of the transformer TD-10 site, looking northwest.

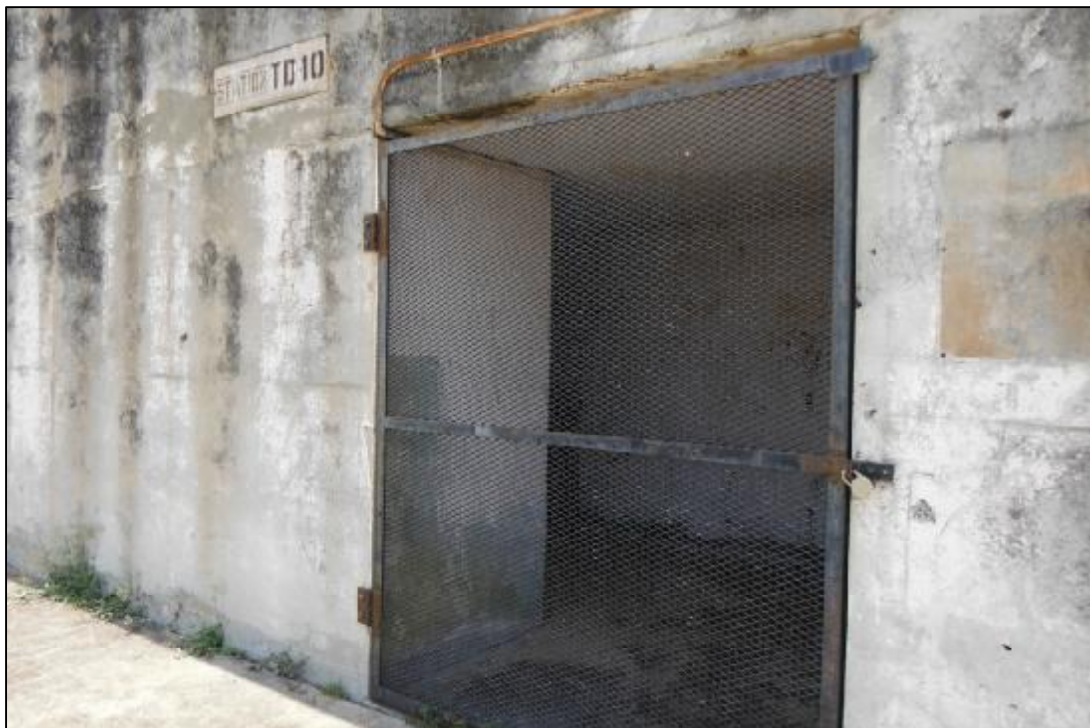
Photograph No. 2: Locked gate restricting access to the TD-10 LUC area.

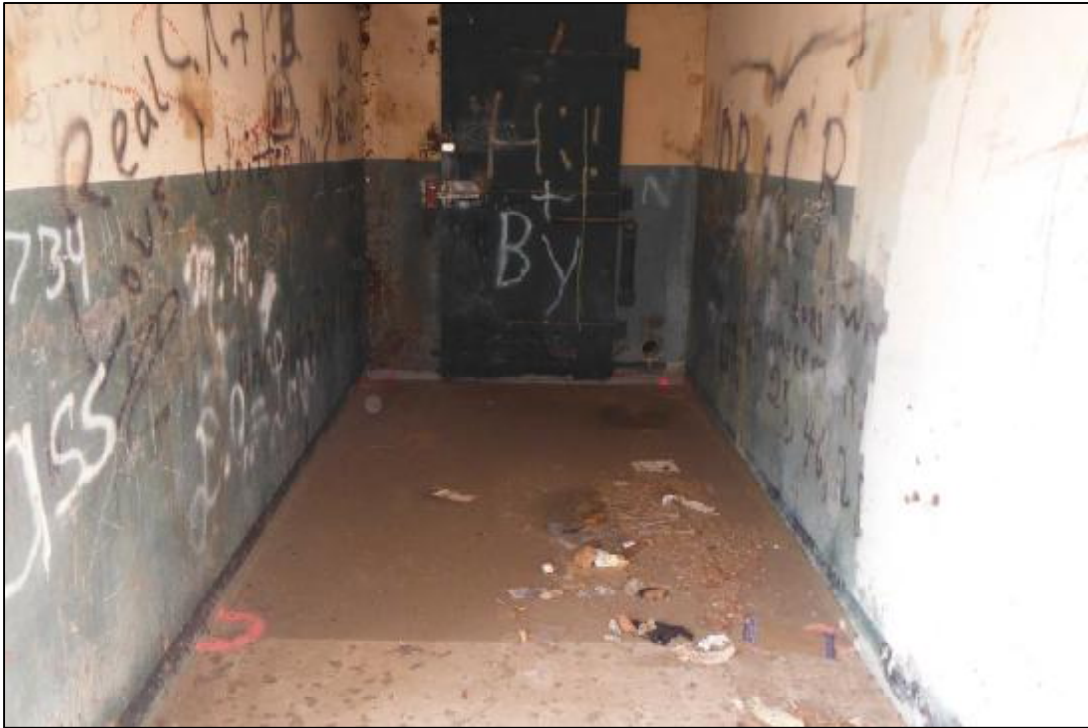
Photograph No. 3: Transformer TD-10 LUC area.

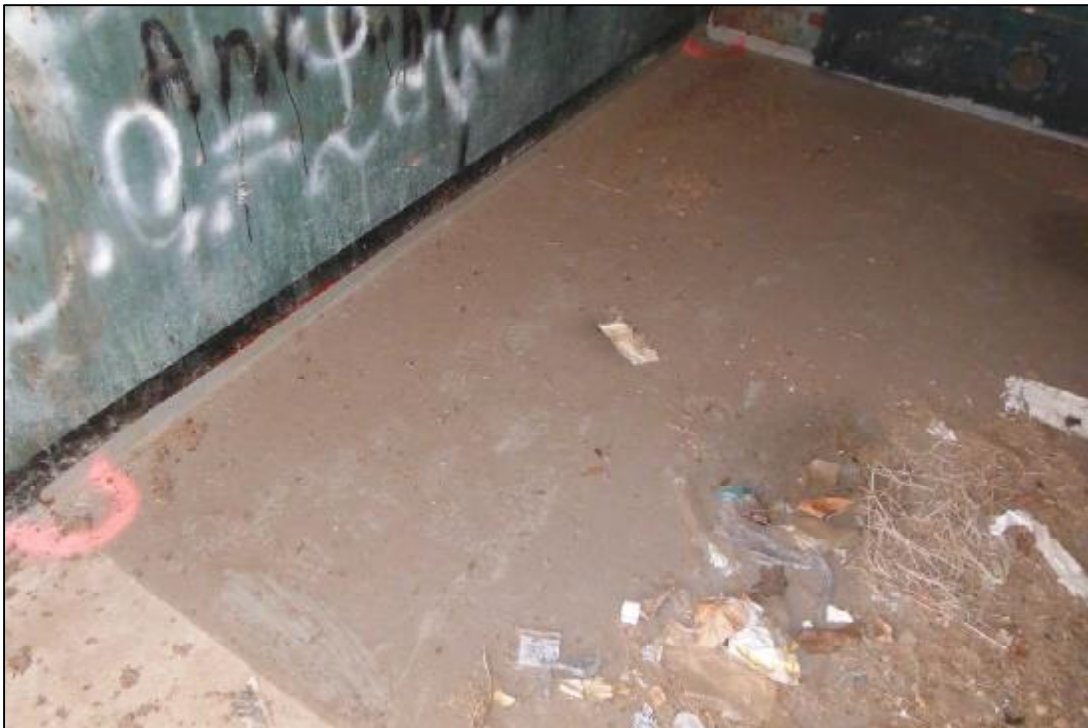
Photograph No. 4: Epoxy coating in TD-10 LUC area.

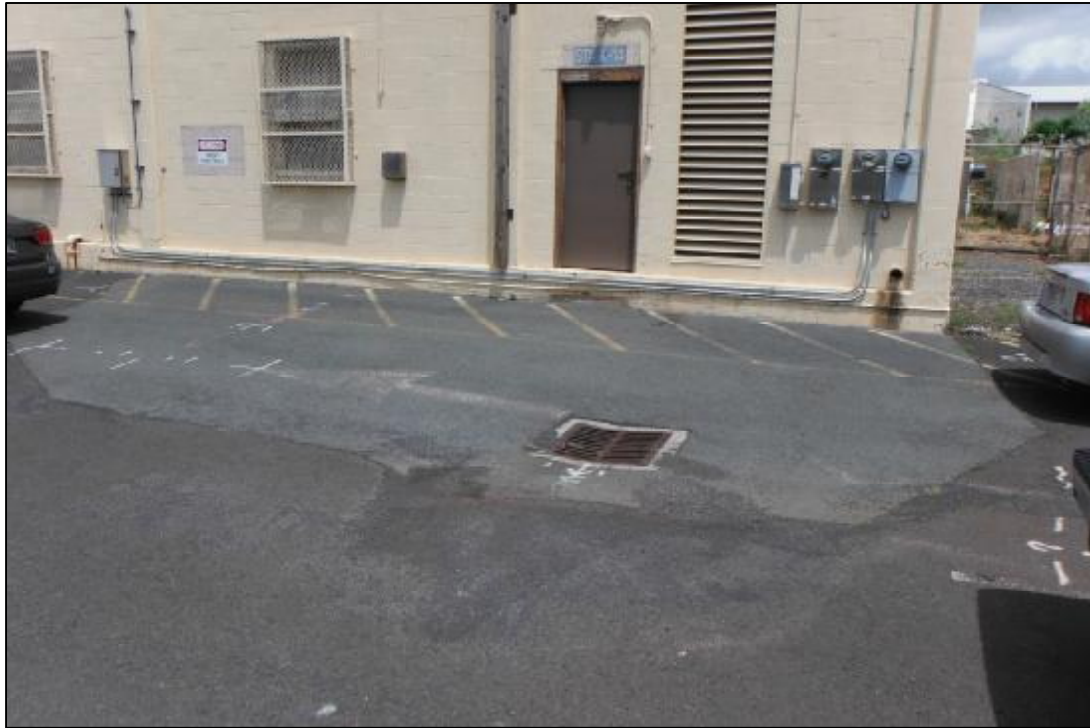
Photograph No. 5: Asphalt-paved LUC area at transformer K-14.

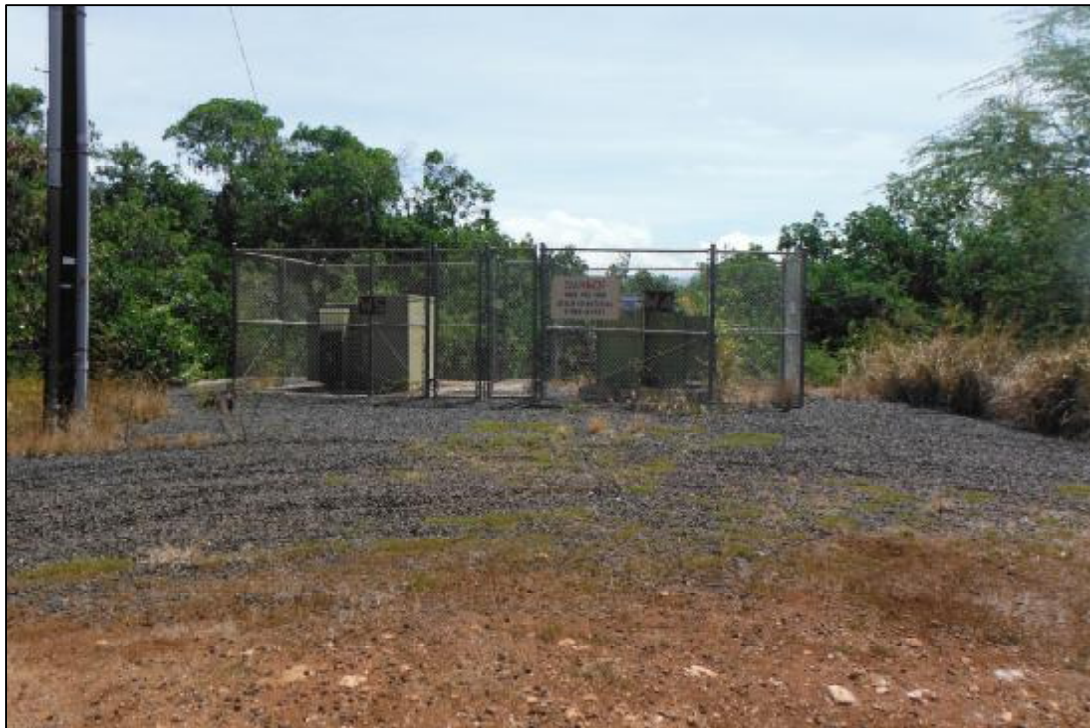
Photograph No. 6: Overview of the transformers W-4/W-5 site.

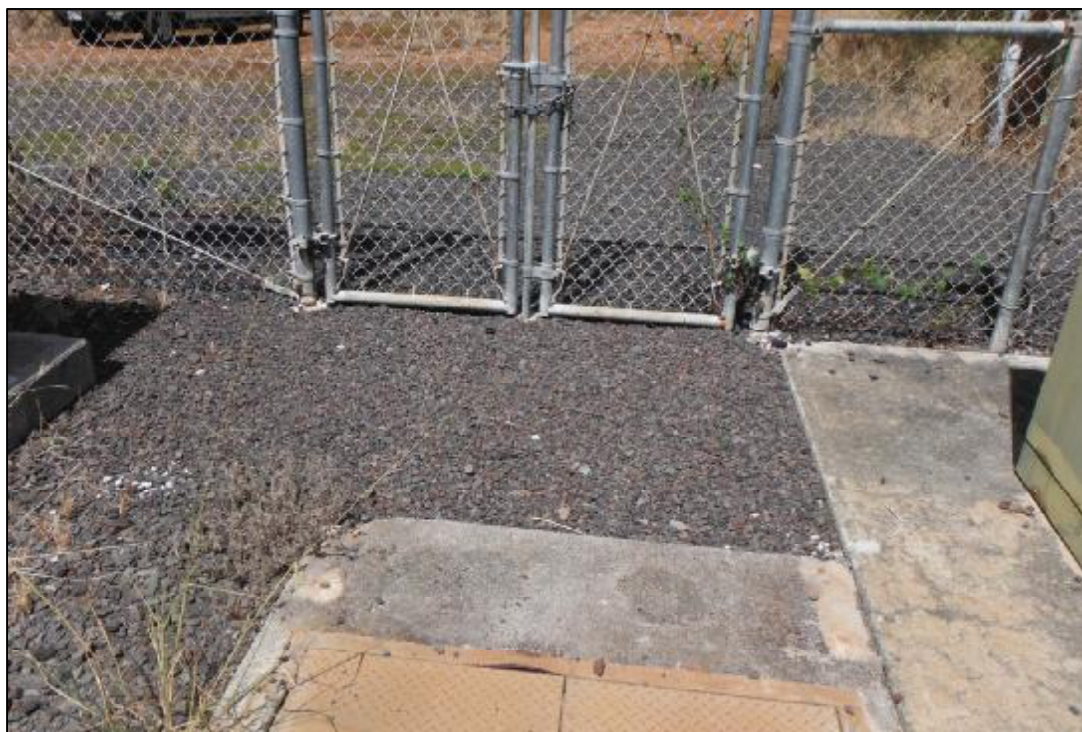
Photograph No. 7: Graveled LUC area behind locked gate at transformer site W-4/W-5.

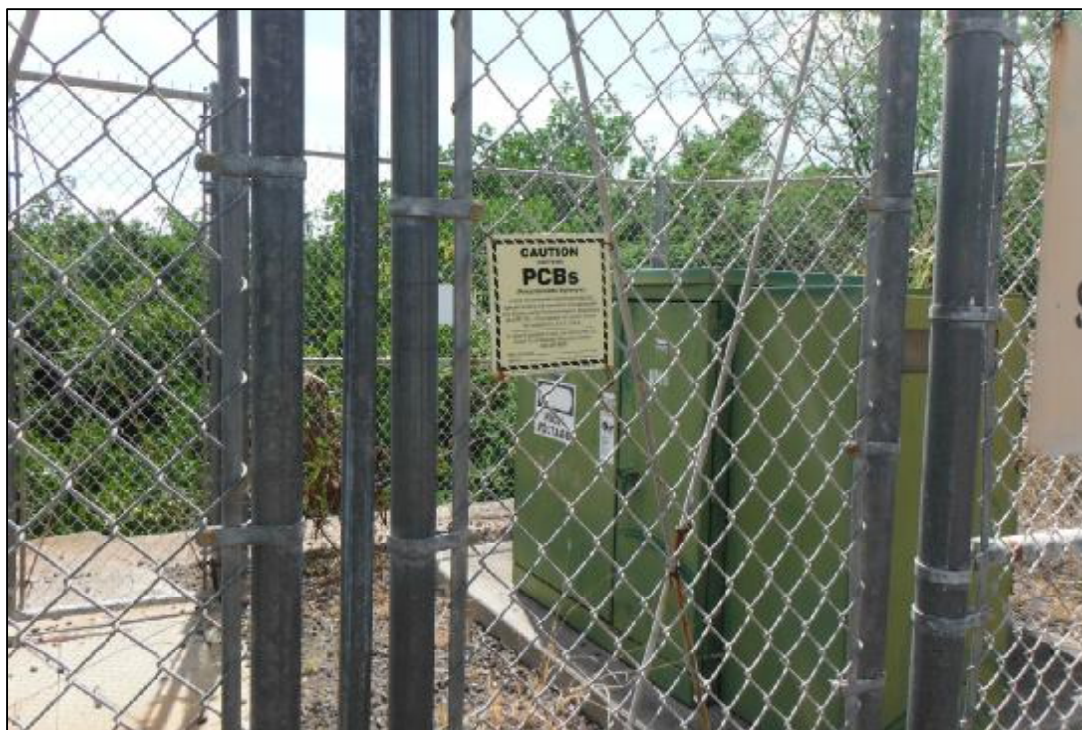
Photograph No. 8: PCB warning sign on fencing directly in front of LUC area at transformer site W-4/W-5.

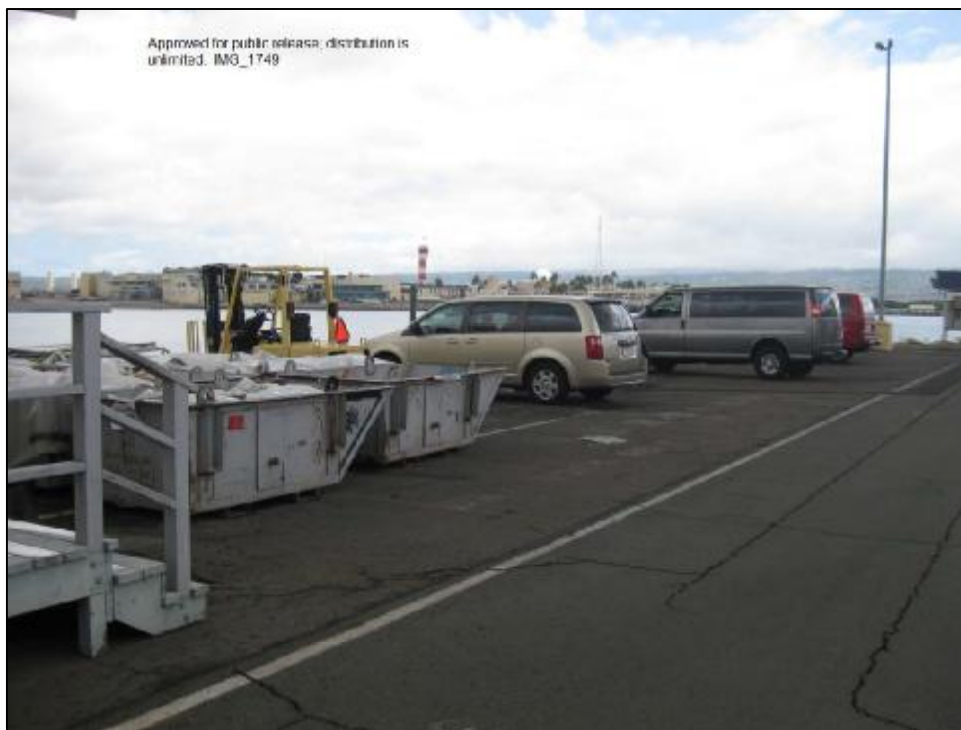
Photograph No. 1: Overview of Shoreline Site Northwest of Dry Dock #3 site, looking north.

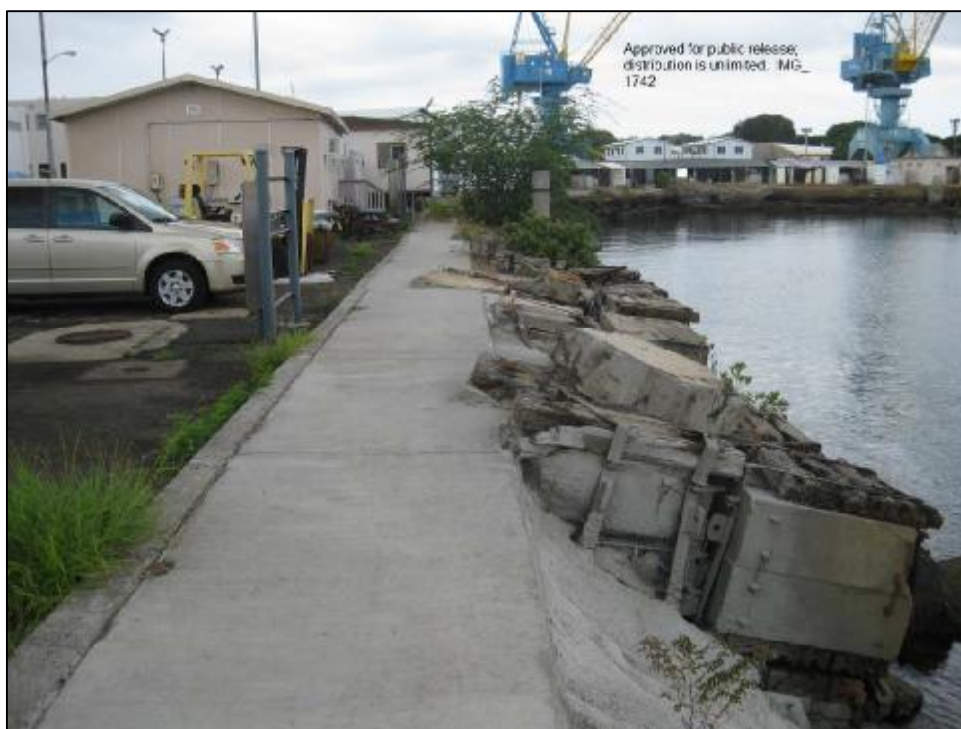
Photograph No. 2: Concrete blocks and curb protecting the site from erosion, looking southwest.

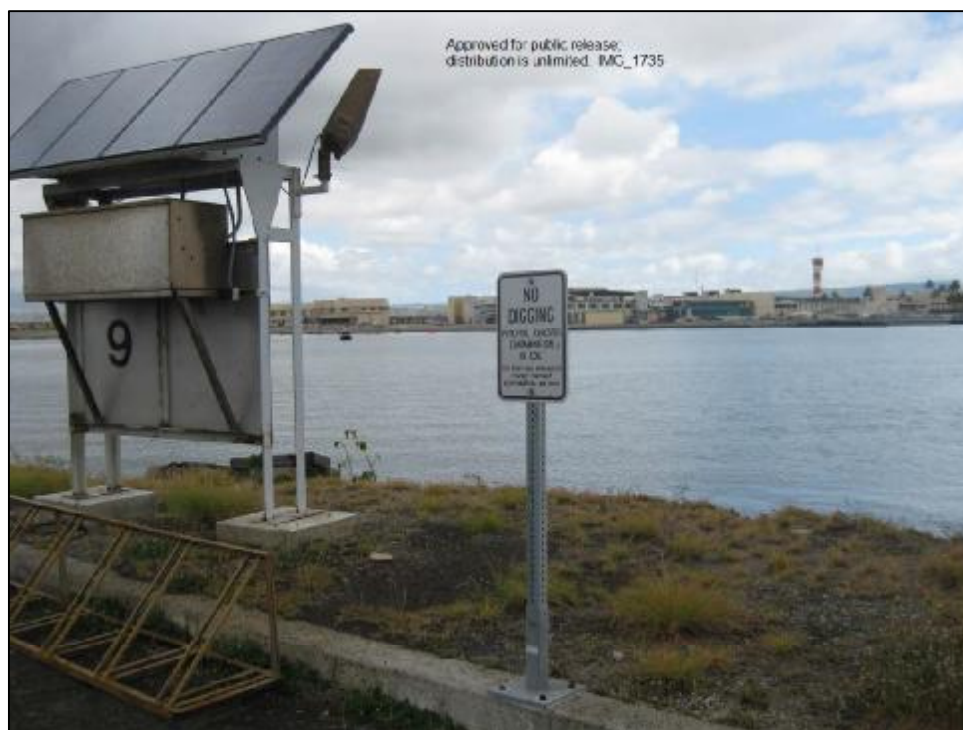
Photograph No. 4: View of LUC sign near shoreline, looking northeast.

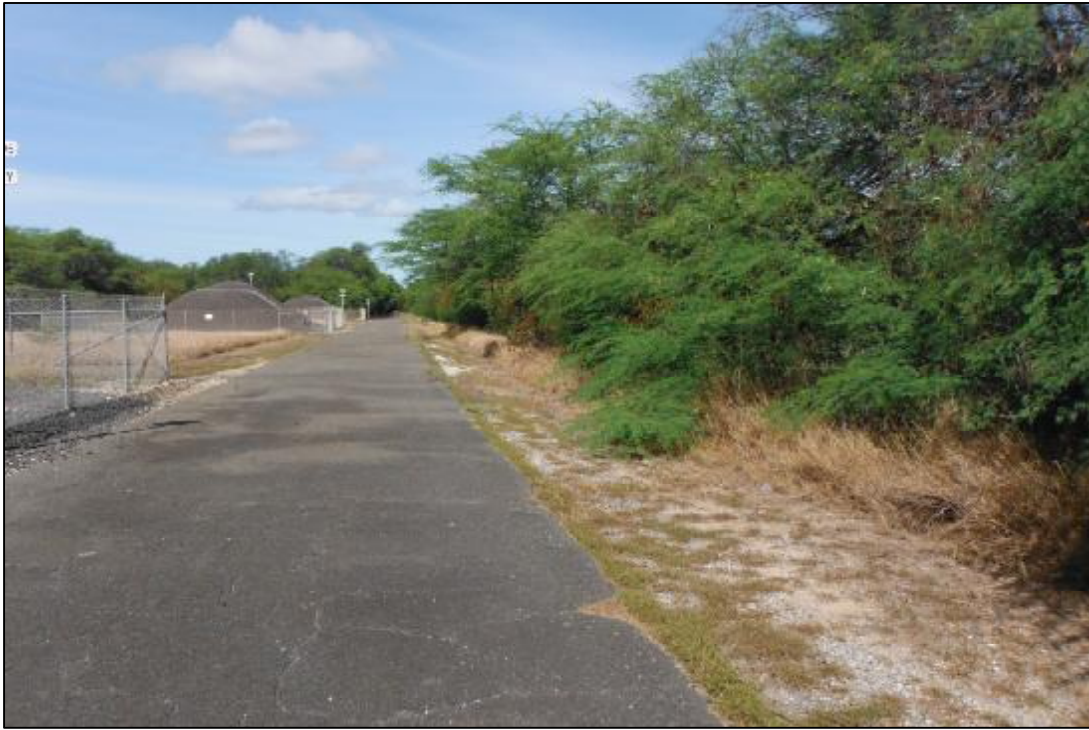
Photograph No. 1: Overview of south border of LUC area, looking southwest down 4th Street.

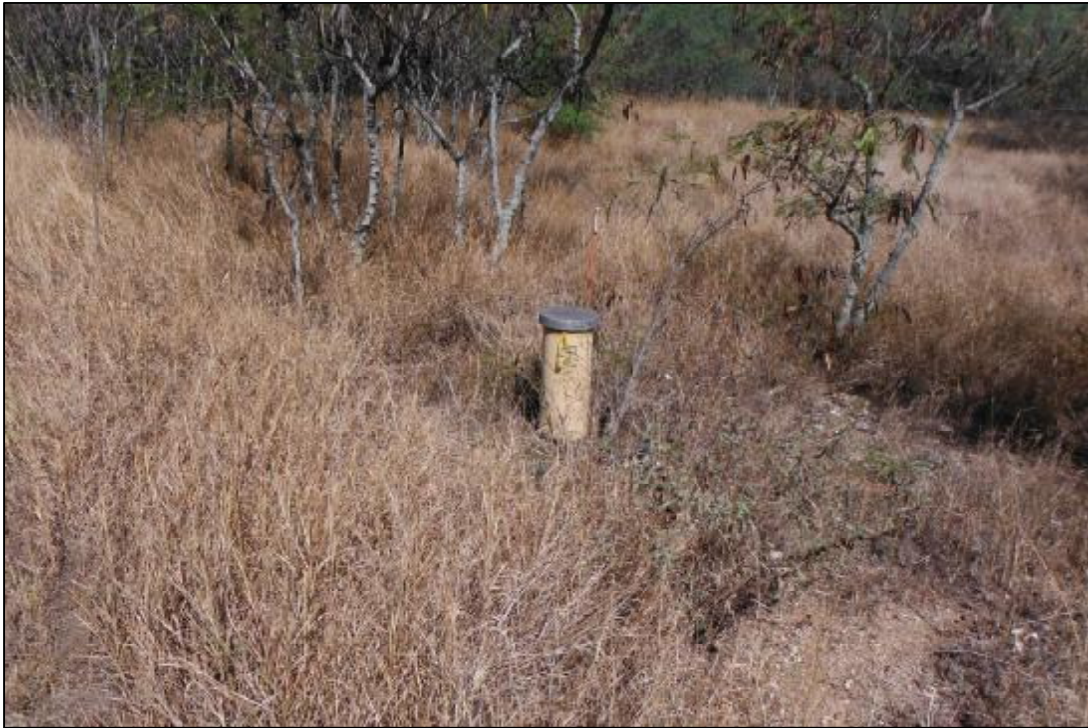
Photograph No. 3: Observed groundwater monitoring well in LUC area.

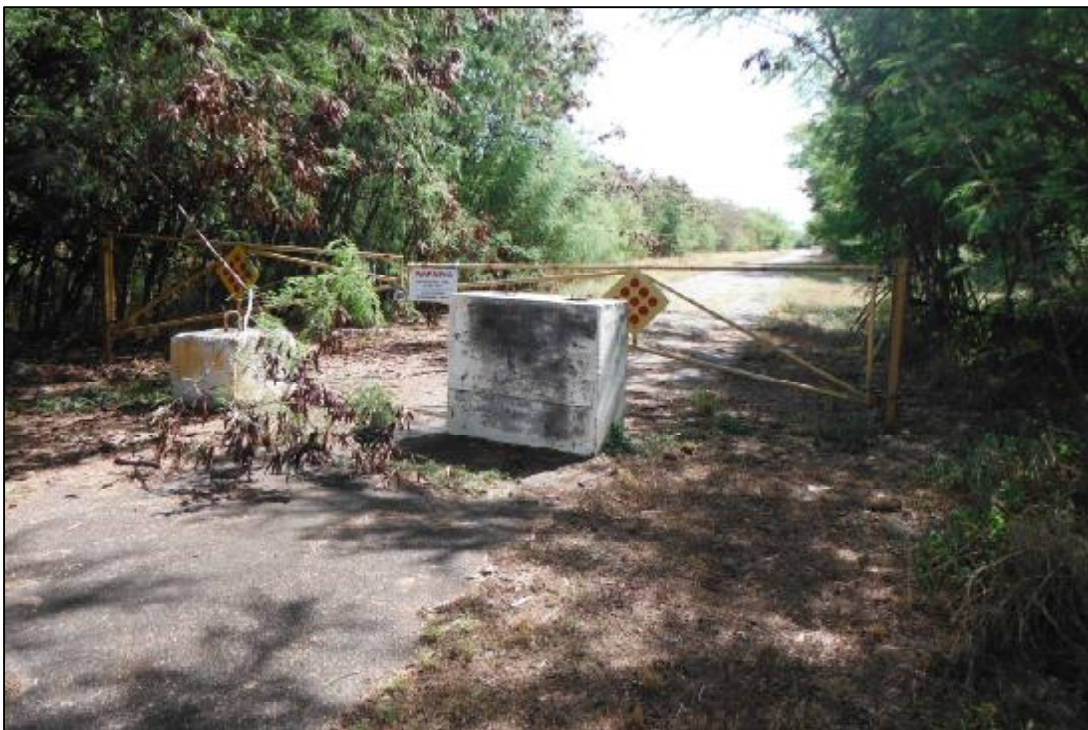
Photograph No. 4: Secured gate and signage restricting access onto 4th Street in the direction of the LUC area.

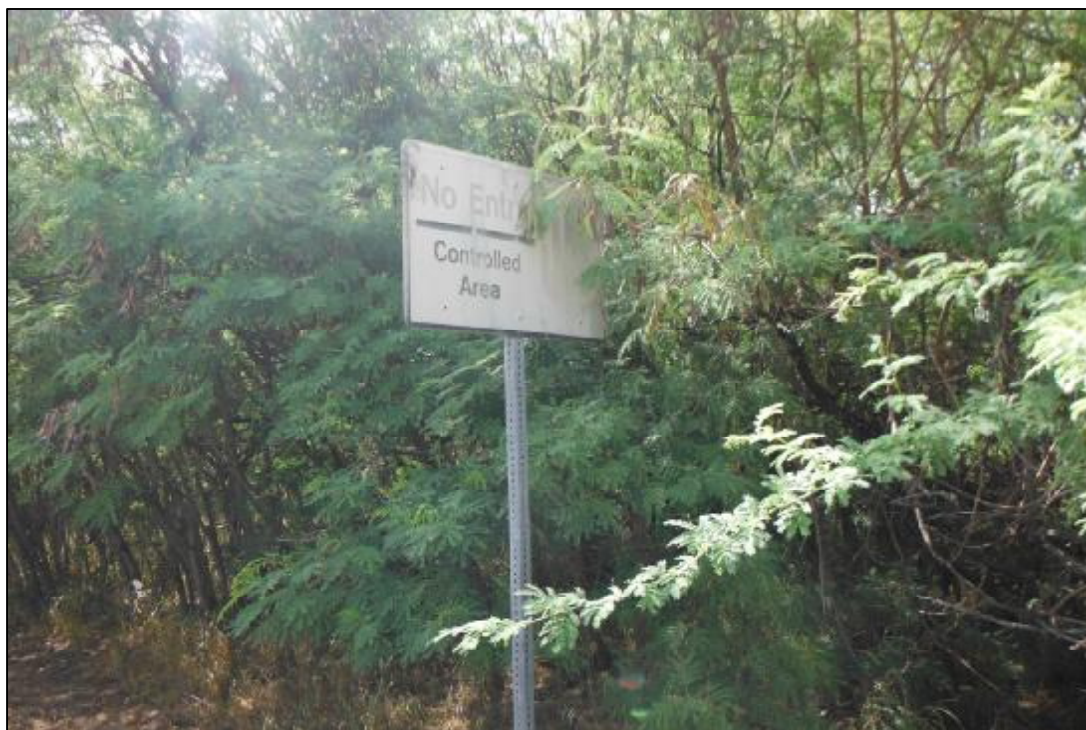
Photograph No. 5: Signage posted in front of gate restricting access from 3rd Street in the direction of the LUC area.

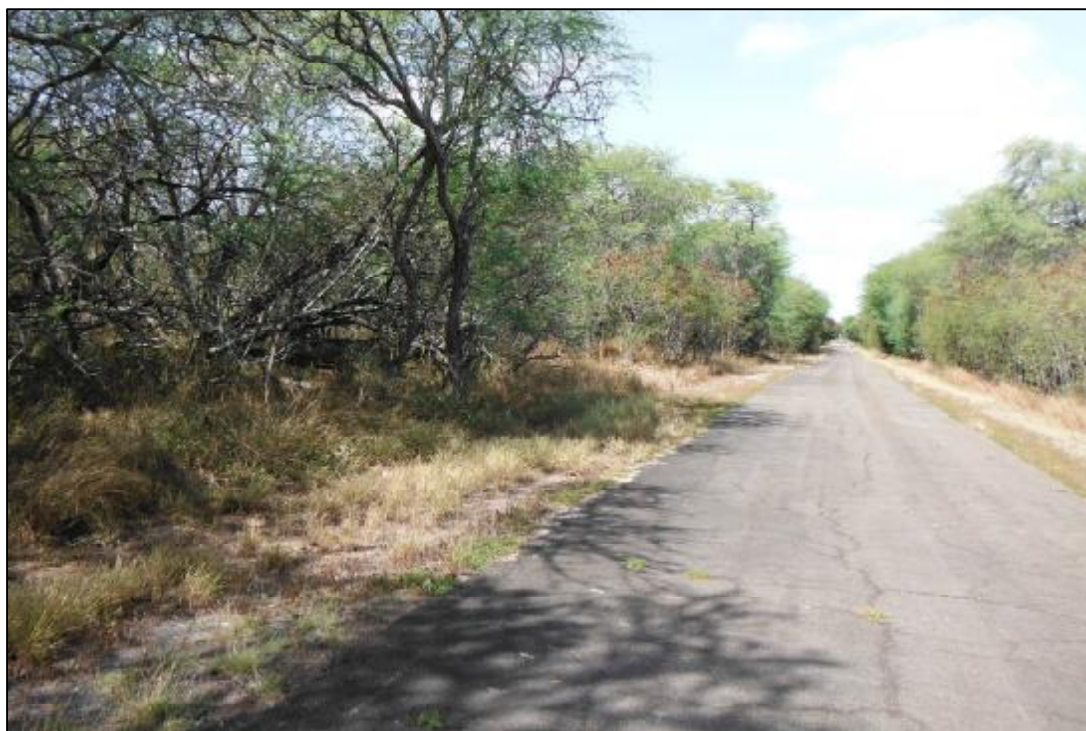
Photograph No. 6: Overview of the north part of LUC area, looking southwest down 3rd Street.

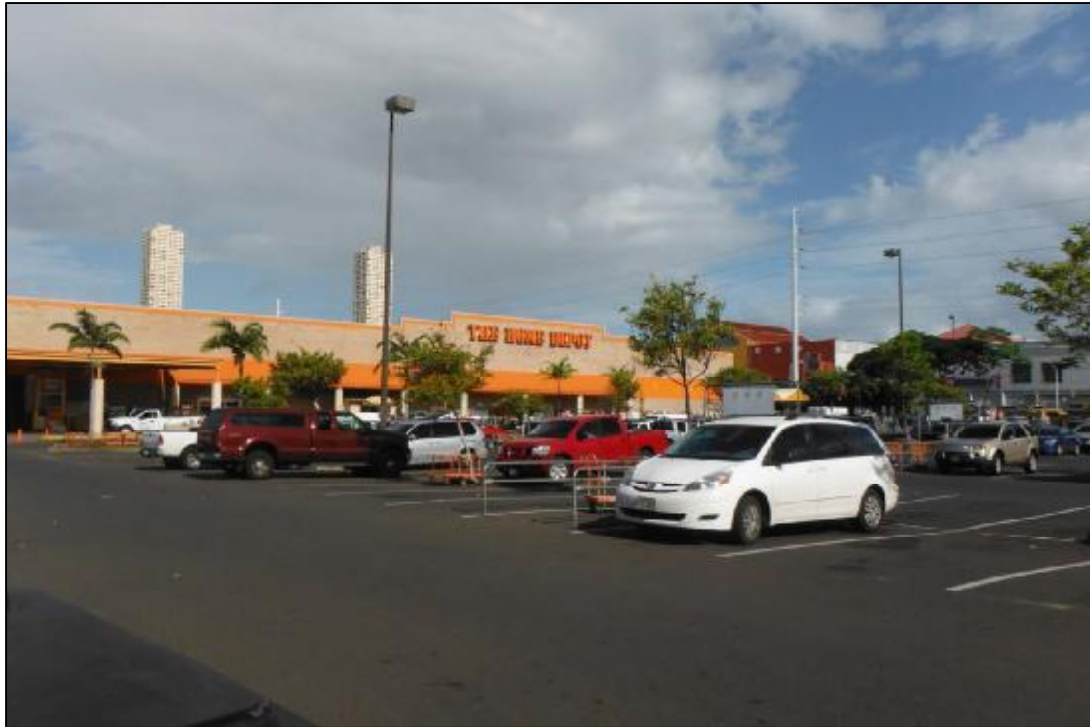
Photograph No. 1: Overview of west part of the site including Home Depot retail facility, looking northwest.

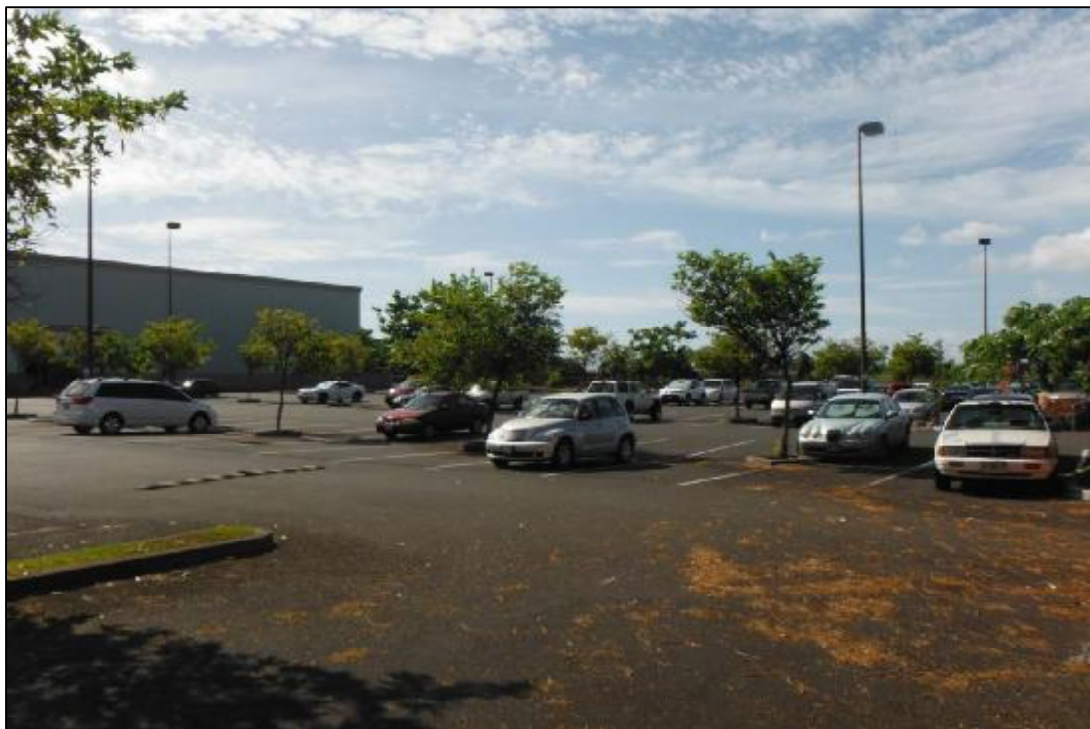
Photograph No. 2: Overview of the east part of the site, looking southeast.

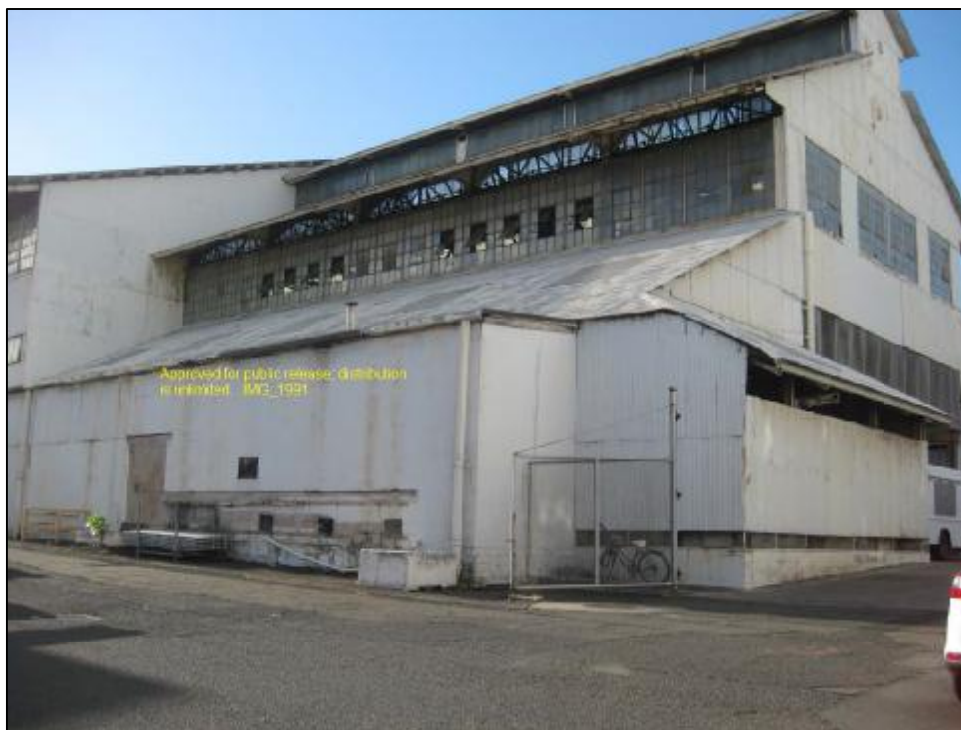
Photograph No. 1: Overview of Bldg. 6 site, looking south.

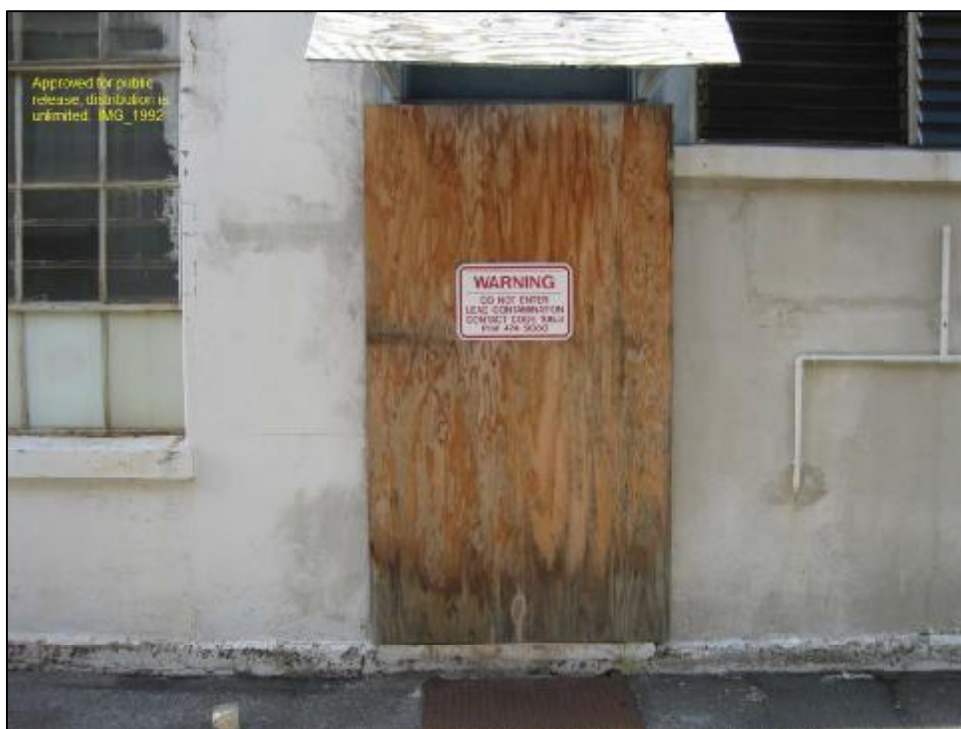
Photograph No. 2: Sign at north entrance of building indicating lead hazards exist within the building.

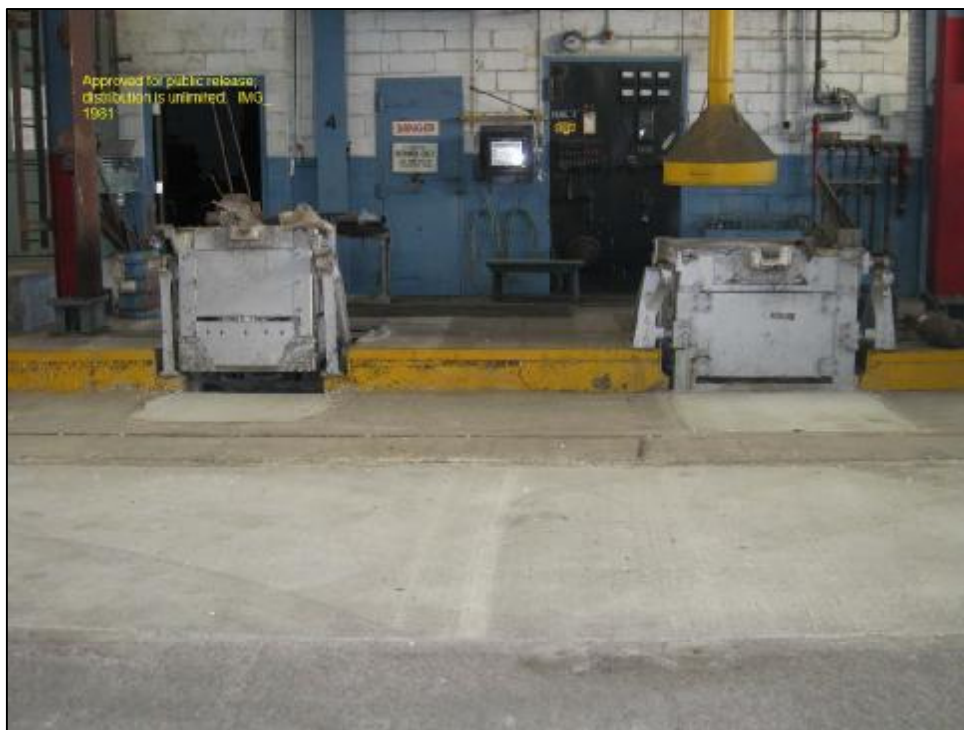
Photograph No. 3: View of pits and unpaved surfaces within Bldg. 6 that were covered in concrete.
